# **INDOOR AIR QUALITY ASSESSMENT**

**Massachusetts Rehabilitation Commission  
1 Federal Street, Building 102-1  
Springfield, Massachusetts**

Prepared by:  
Massachusetts Department of Public Health  
Bureau of Environmental Health  
Indoor Air Quality Program  
April 2008

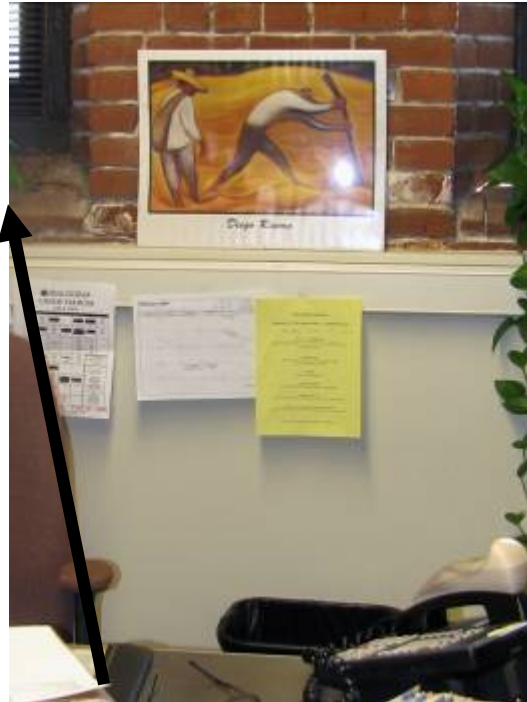
**Picture 1**

**Note Slope on Brick Window Sill**

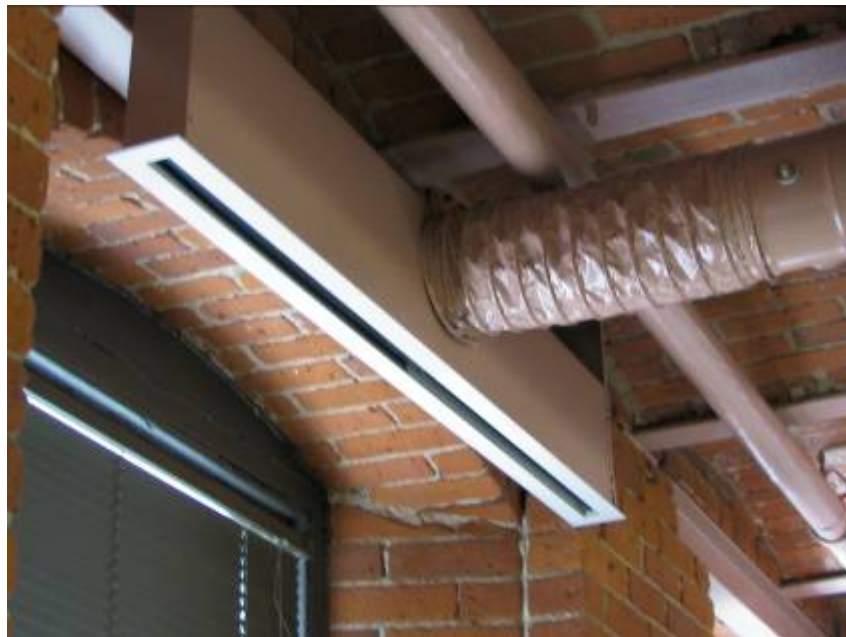
**Picture 2**

**Fresh Air Diffuser**

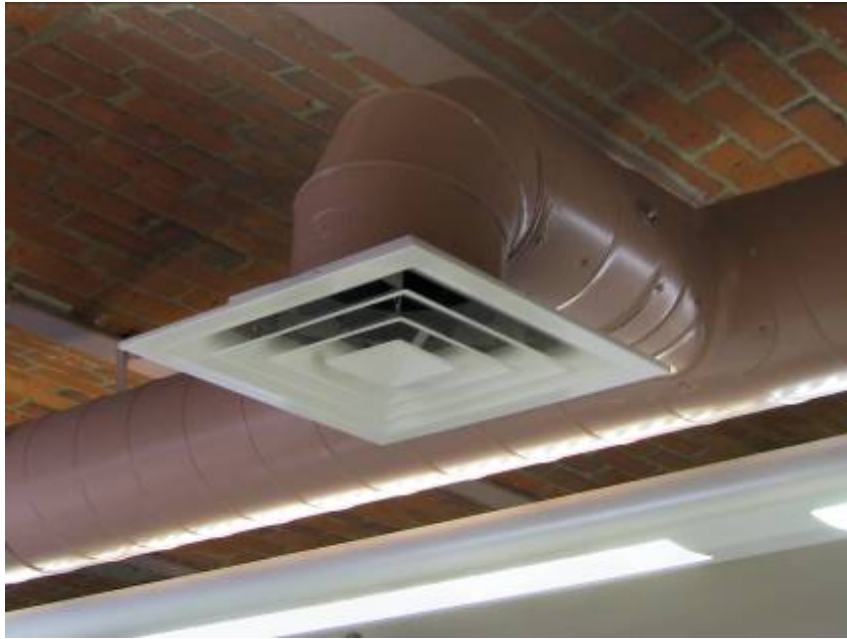
**Picture 3**

**Fresh Air Diffuser**

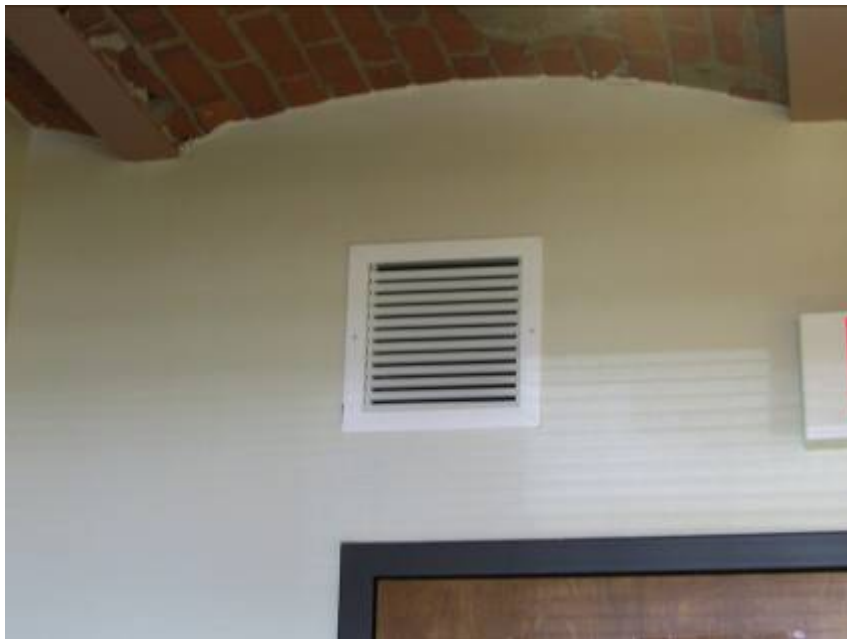
**Picture 4**

**Exhaust Vent**

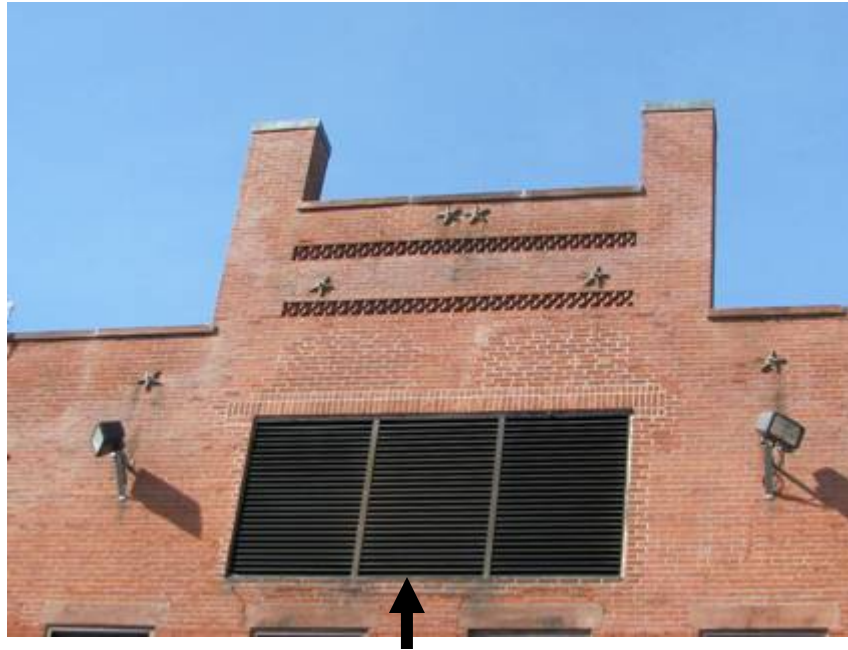
**Picture 5**

**Typical Fresh Air Intake**

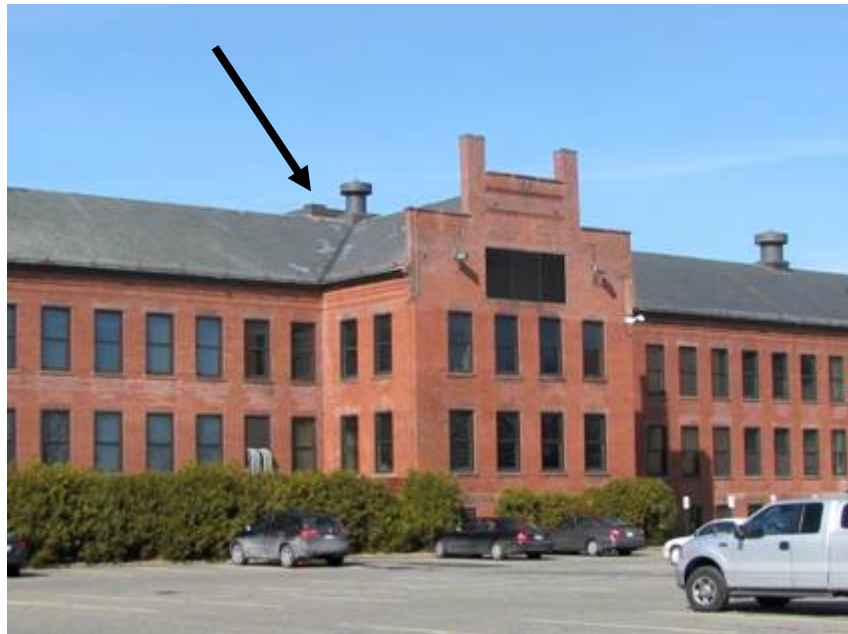
**Picture 6**

**Typical Exhaust Vent**

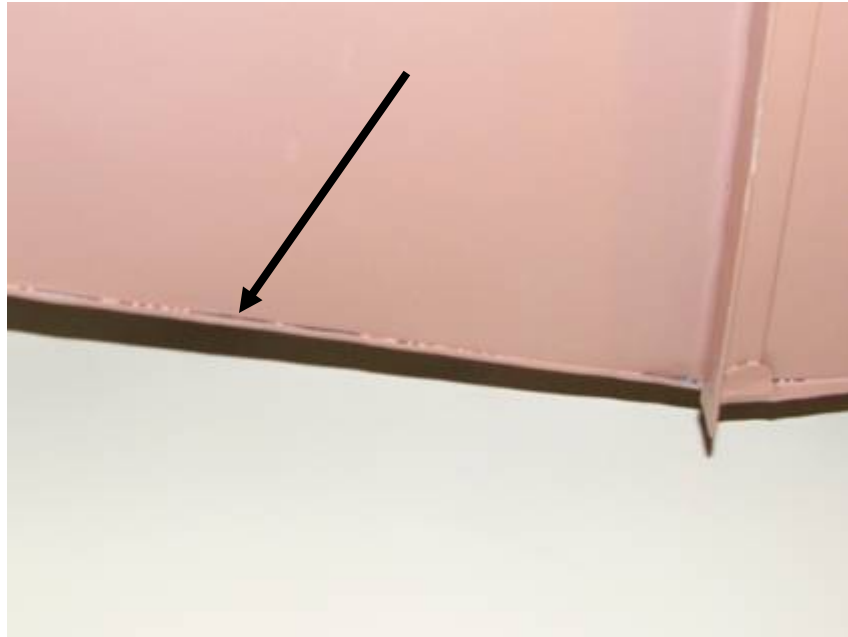
**Picture 7**

It appears that the heating, ventilating and air-conditioning (HVAC) is responsible for distributing the fuel odor throughout the MRC space. A large return vent duct exists in this closet, which has unsealed seams (Picture 7). It is likely that the fuel odor is drawn through these seams to the air handling unit (AHU), which then distributes the odor. Due to the depressurization of the closet, it is likely that the odor is being pulled into the storage room through either a hole or crack in the floor or by a penetration of pipe or conduit that has not been properly sealed. Fuel odors should not be present in a typical, indoor environment. Fuel vapor can cause eye, nose, throat and respiratory system irritation.

**Unsealed Seams on Duct**

1. Empty and investigate storage closet for pathways that are not properly sealed.
2. Identify and eliminate the source of the fuel odors.
3. Seal the pathways in the vents and in the closet itself.
4. Remove pictures/diplomas from resting directly against brick wall, particularly on south side of the building.
5. Remove newspapers and any porous materials from below plants.
6. Remove plants that are resting on the carpet.
7. Ensure all plants have drip pans that are periodically examined for mold growth.
8. Eliminate use of air fresheners.
9. Seal penetrations of interior and exterior walls in addition to those observed in the brick ceiling surfaces.

1. An HVAC engineer should be consulted to balance the system, to recommend an appropriate sealant for the ducts and to resolve any additional air supply/exhaust issues for the building.

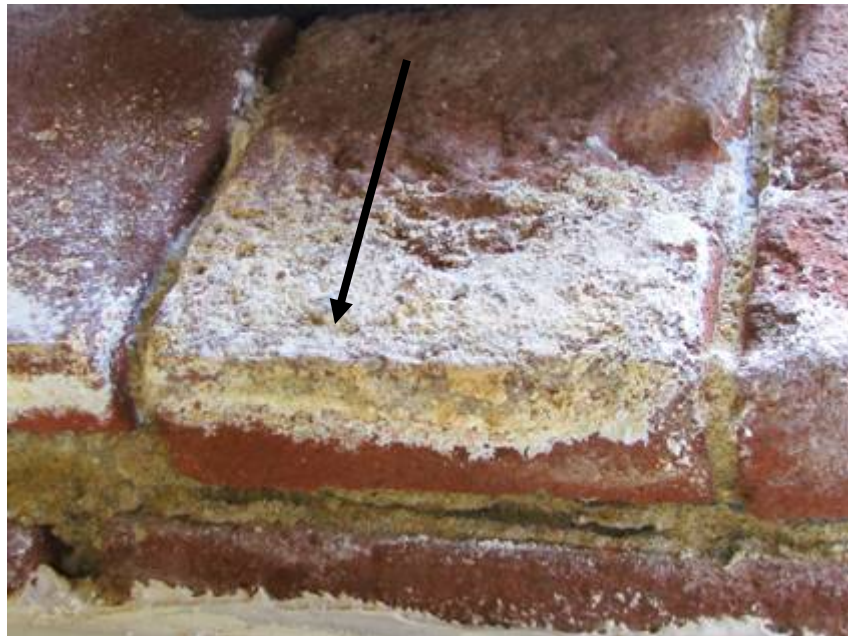
**Picture 8**

Numerous areas suggested evidence of microbial/moisture invasion on both the interior and exterior of the building. Efflorescence was observed on numerous brick surfaces throughout the interior of the building (Picture 8). Efflorescence is caused by water penetration dissolving minerals within the brick/mortar as it flows through. The water evaporates on the surface leaving behind a dry white residue. While efflorescence is a characteristic sign of water penetration, it is not mold growth. This condition was observed primarily on the beveled window sills in numerous offices, but was also observed on walls throughout the office space

**Efflorescence on Brick of Slanted Window Sill**

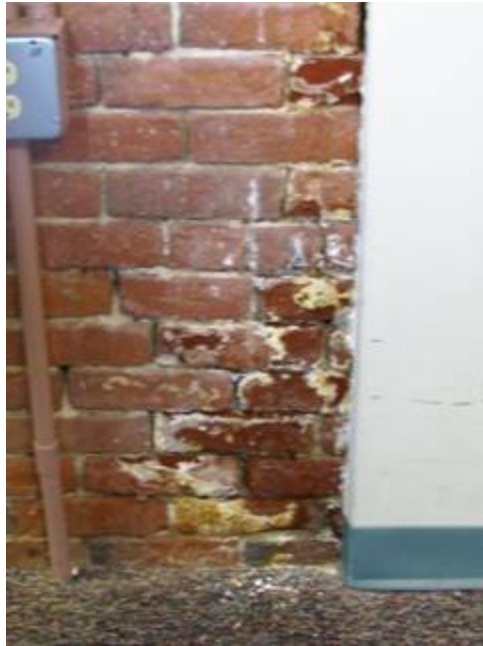
**Picture 9**

**Efflorescence and Missing Mortar on Interior Wall**

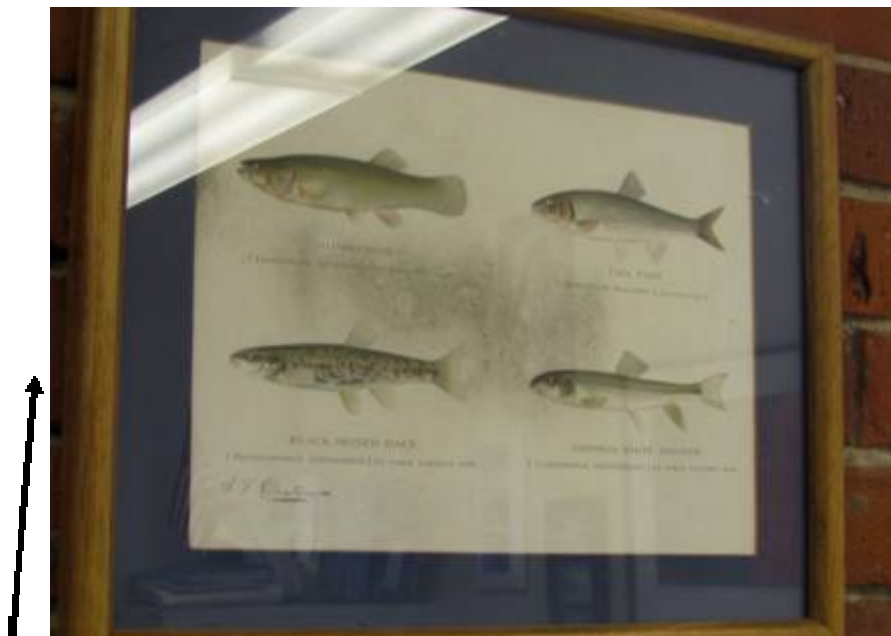
**Picture 10**

(Picture 9). Brick walls on which photographs or posters were displayed revealed mold if the surface touching the wall was permeable to water and efflorescence if it was not (Pictures 10-14). It was reported by MRC staff that numerous documents such as diplomas hung on these walls had developed mold over time and had to be removed from the office. The large amount of efflorescence observed on these slanted window sills may be due to water penetration below each window casing. Therefore, each exterior window casing should be examined for deteriorated areas of mortar and caulking and should be repaired as required. The efflorescence observed on the interior walls may be caused by one of the following conditions:

**Mold Growth on Picture Hung On Brick Wall**

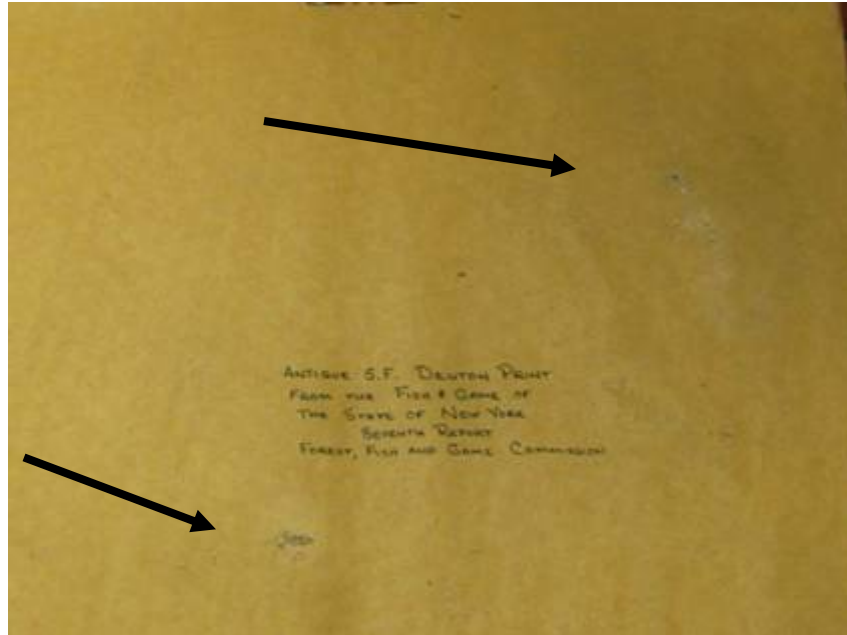
**Picture 11**

**Paper Backing on Fish Picture Supports Mold Growth**

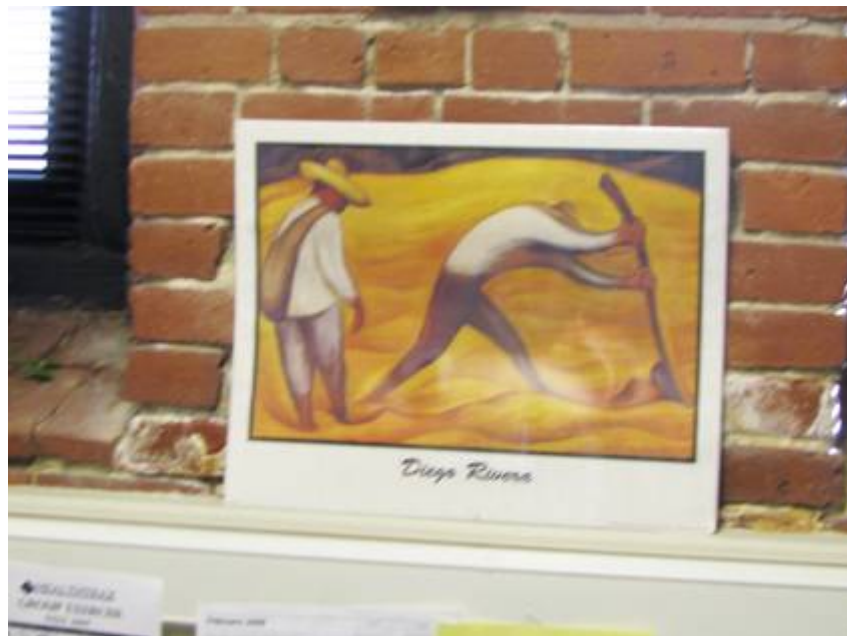
**Picture 12**

**Picture Wrapped In Plastic Leaning Against Wall**

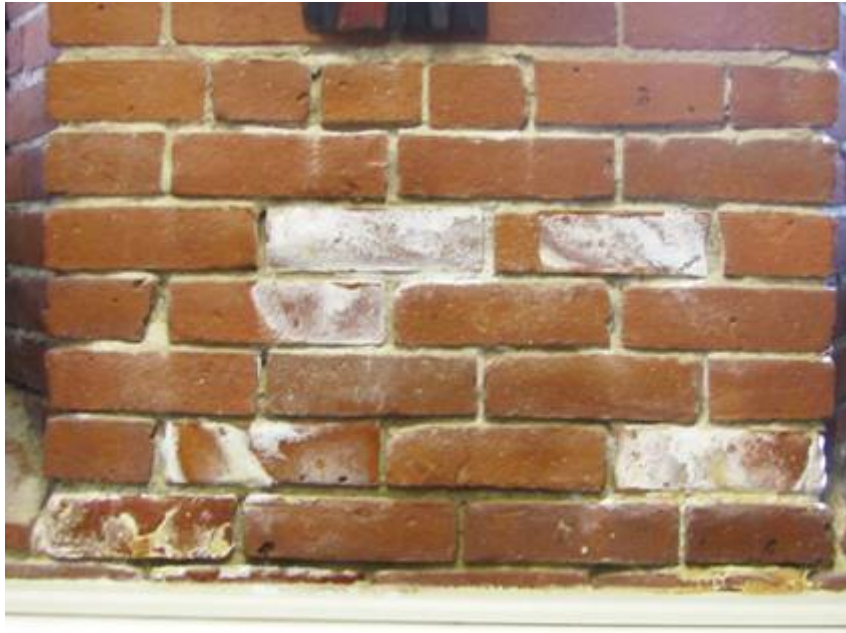
**Picture 13**

**Efflorescence Observed On Wall behind Picture**

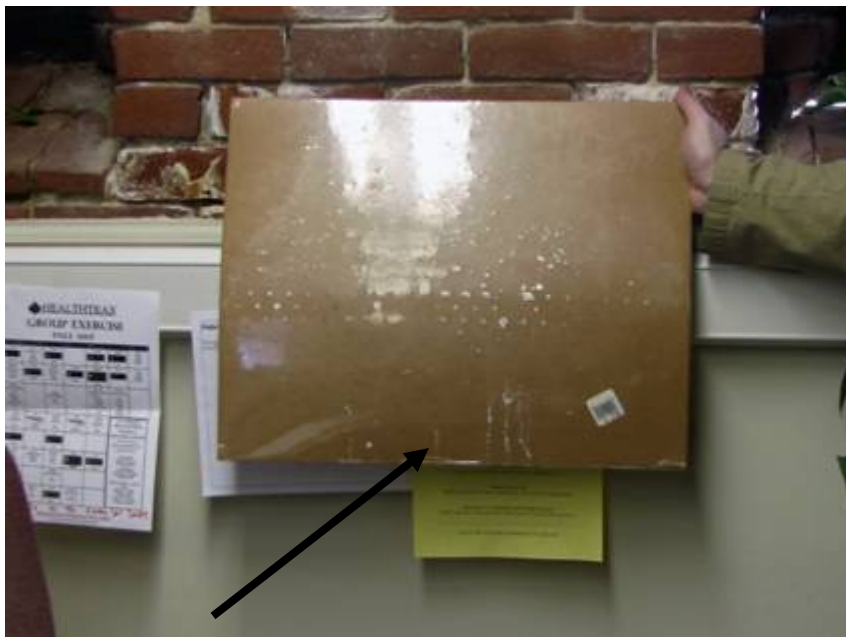
**Picture 14**

**Efflorescence Observed On Impervious Plastic  
Wrap On Back Of Picture**

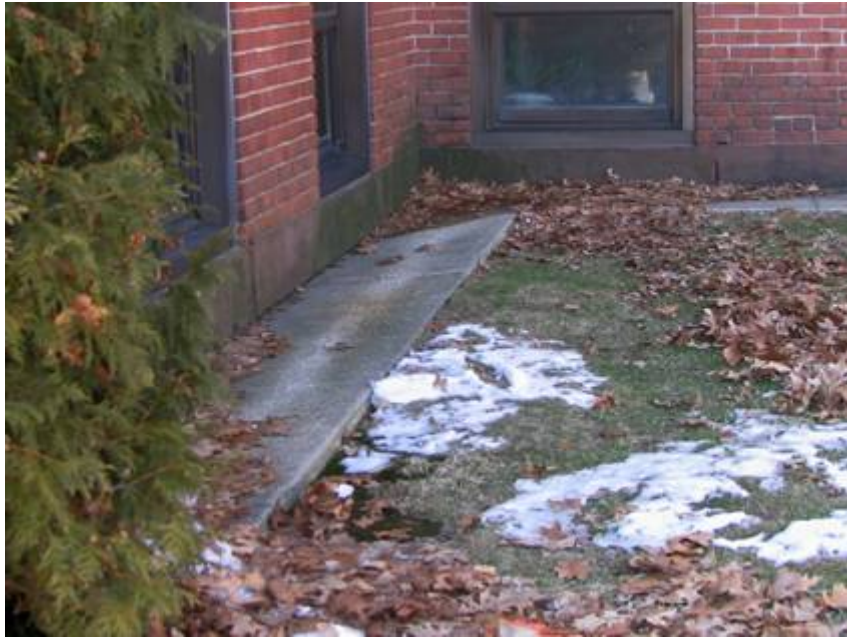
**Picture 15**

1. Brick and mortar on the exterior of the building has deteriorated.
2. Water is currently being directed toward the building due to the slant of the apron adjacent to the building (Picture 15)
3. Numerous open utility holes were observed in the walls, which can serve as pathways for moisture, drafts, dust and debris into occupied areas (Picture 16). Penetrations of pipes were not properly sealed between offices as well (Picture 17).
4. Rusted nail in wall is indicative of a temperature bridge, which can generate condensation in the heating season (Picture 18).

2. Consider consulting a civil engineer regarding exterior apron and to assist in determining a remedy for the water which currently drains toward the base of the building.
3. Consider contracting with a mason to repair and repoint bricks on the exterior of the building.
4. Consider examining and sealing areas around windows that are no longer in good repair and which may now be allowing moisture to enter the building.

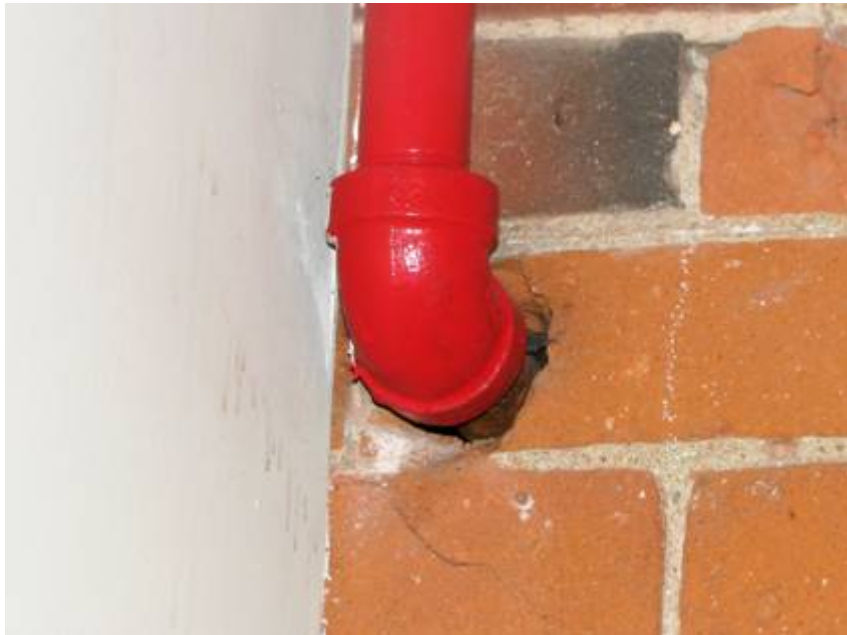
**Picture 16**

**Penetration of Pipe through Wall Is Not Properly Sealed**

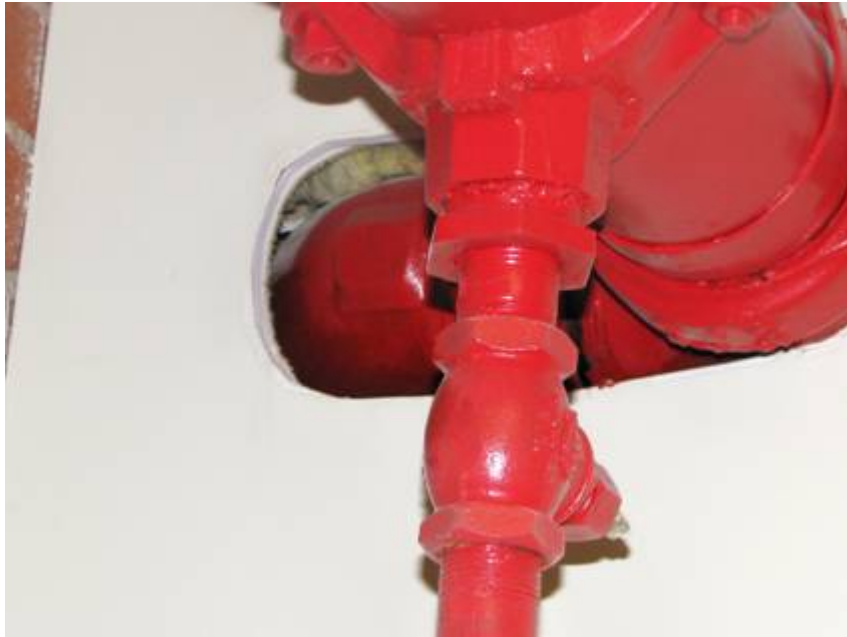
**Picture 17**

**Penetration of Pipes through Office Walls Is Not Properly Sealed**

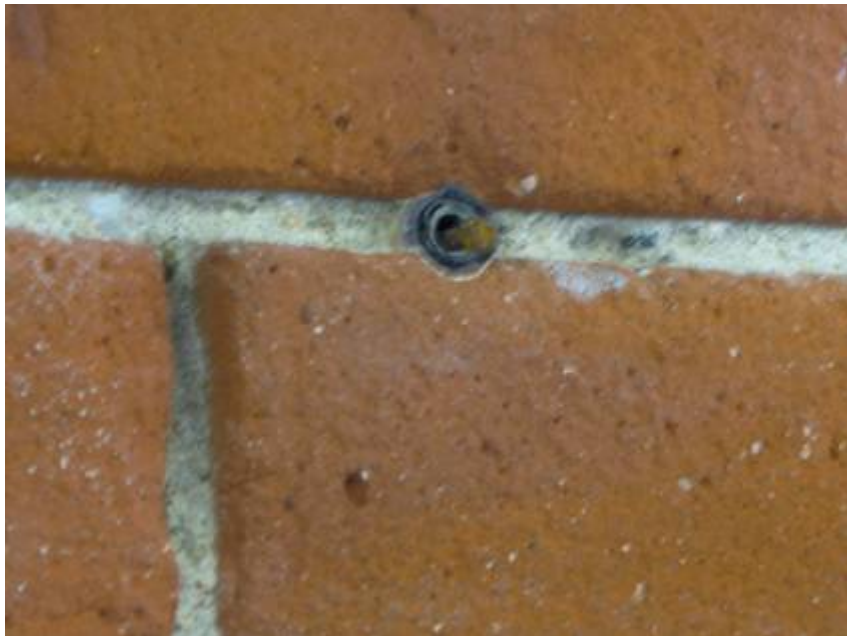
**Picture 18**

**Rusted Nail in Wall**

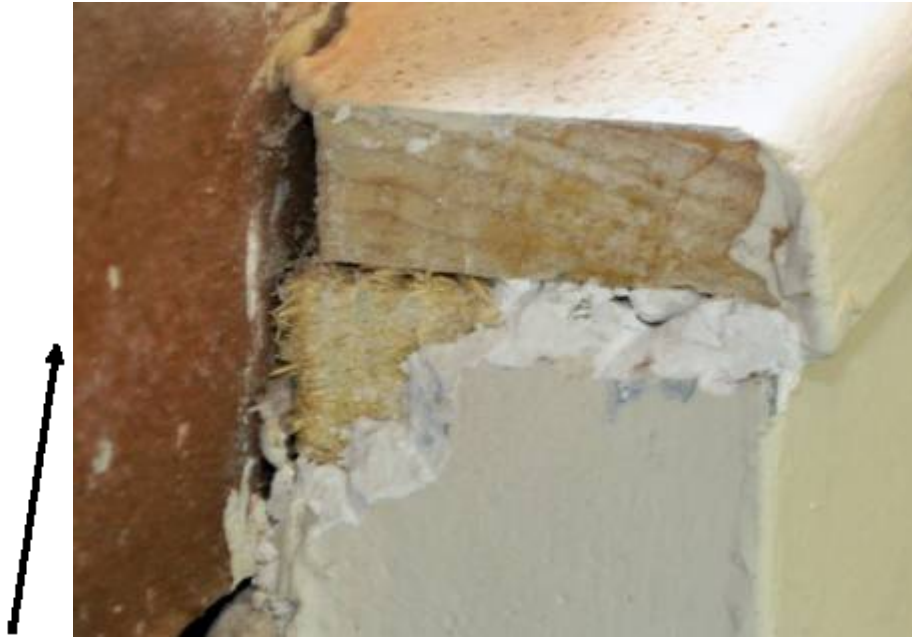
**Picture 19**

The wall adjacent to the supply area exhibited a large amount of efflorescence as well as water damaged plaster/joint compound and missing/damaged mortar. Moisture entering the interior wall space would create mold if the brick was adjacent to gypsum wallboard (GW). Further investigation revealed that the interior wall surfaces adjacent to the brick was not GW, but was wood coated with plaster/joint compound. Wood is much more resistant to mold growth, however, with repeated saturation, may eventually support mold growth (Picture 19). Additionally, water-damaged wall plaster can, under certain circumstances, provide a medium

**Wall Adjacent To Brick Is Composed Of Wood**

for mold and mildew growth especially if wetted repeatedly. These materials should be repaired/replaced after moisture damage is discovered.

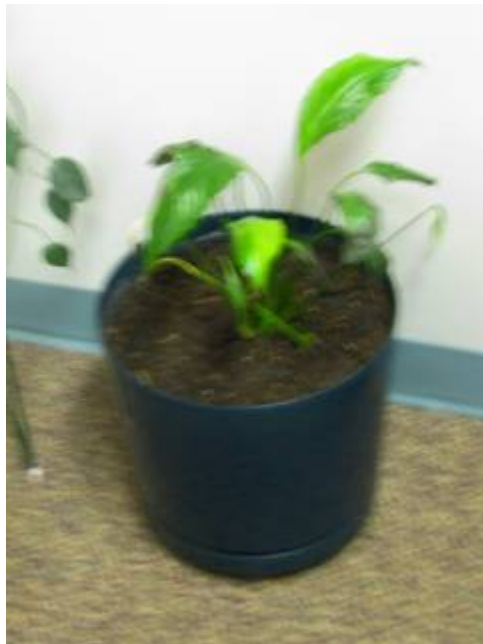
**Picture 20**

**Plant Resting On Carpeting**

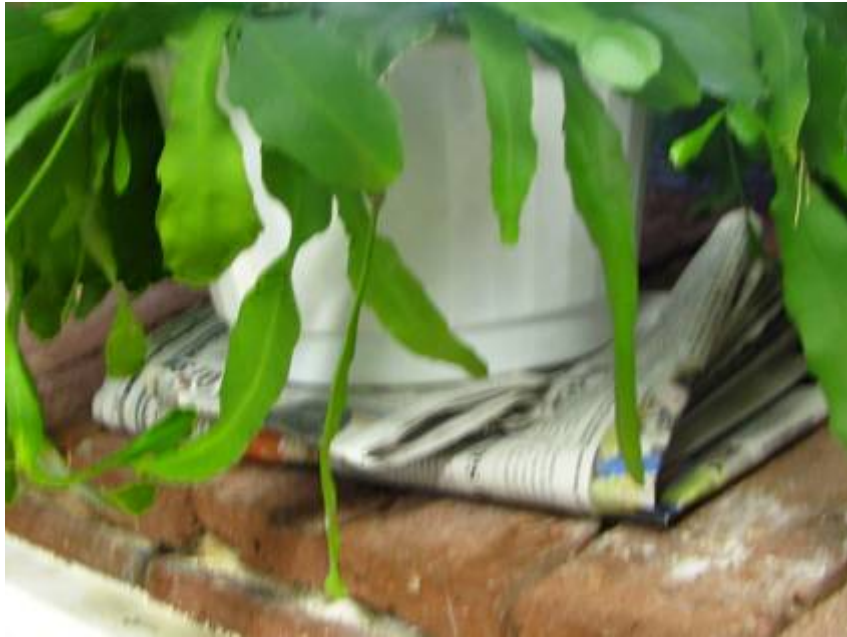
**Picture 21**

Many offices exhibited numerous plants. Moistened plant soil and drip pans can provide a source of mold growth and pollen. Plants should be located away from the air stream of ventilation sources to prevent the aerosolization of mold, pollen or particulate matter. Plants should have drip pans to prevent wetting of porous building materials and subsequent mold colonization. Over watering of plants should be avoided and drip pans should be inspected periodically for mold growth. Plants should not be placed on carpeting (Picture 20). Additionally, some plants were resting on newspaper on the brick window sills. This practice allows moisture to enter the newspaper in two ways, from over-watering the plant and from seepage from the brick sill surface into the newspaper from below (Picture 21). This practice should be eliminated as wet newspaper provides a medium for mold growth.

**Plant Stored On Top Of Newspaper**

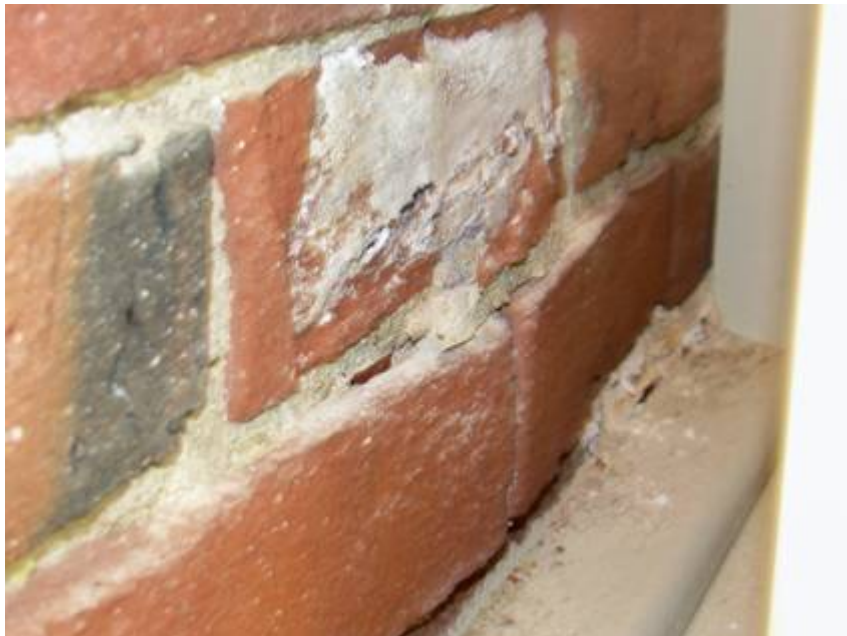
**Picture 22**

Several interior wall areas exhibited cracked and broken brick surfaces, potentially due to moisture traveling from the exterior of the building inward, particularly if a sealant was applied to the interior brick surface (Picture 22).

**Brick Surface Peeling Away**

12. Consider placing plastic mat below water bubbler placed on carpeting.
13. Remove broken portions of brick and brick dust as they occur. Repair interior brick and mortar as necessary.

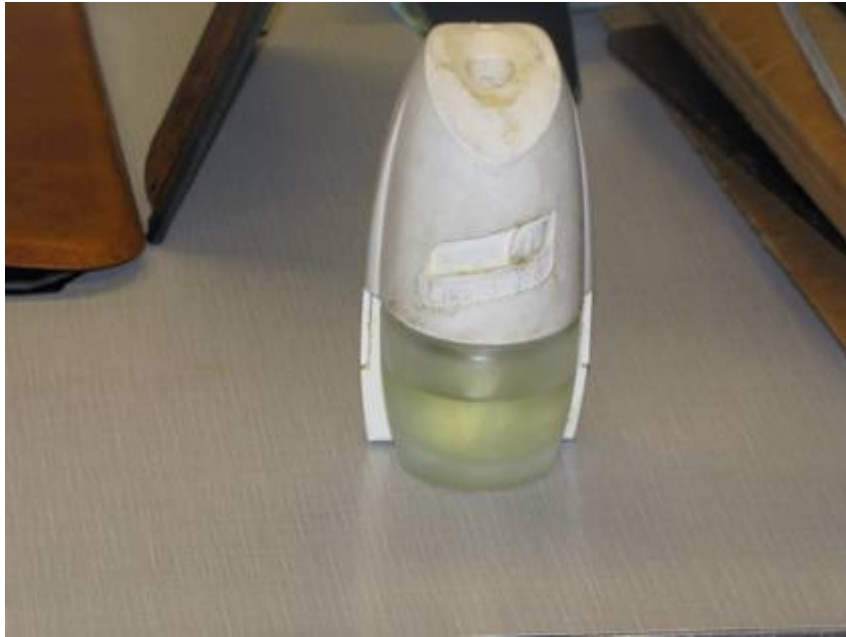
**Picture 23**

storage of or elimination of these materials would serve to enhance the indoor air quality in this building. An air freshener was noted in one of the offices examined (Picture 23). Air fresheners contain chemicals that can be irritating to the eyes, nose and throat of sensitive individuals. Furthermore, air fresheners do not remove materials causing odors, but rather mask odors that may be present in the area. Dry erase markers and boards were observed in the conference room (Picture 24). Materials such as dry erase markers and cleaners may contain VOCs, (e.g., methyl isobutyl ketone, n-butyl acetate and butyl-cellusolve) (Sanford, 1999).

**Air Freshener Located On Desk**

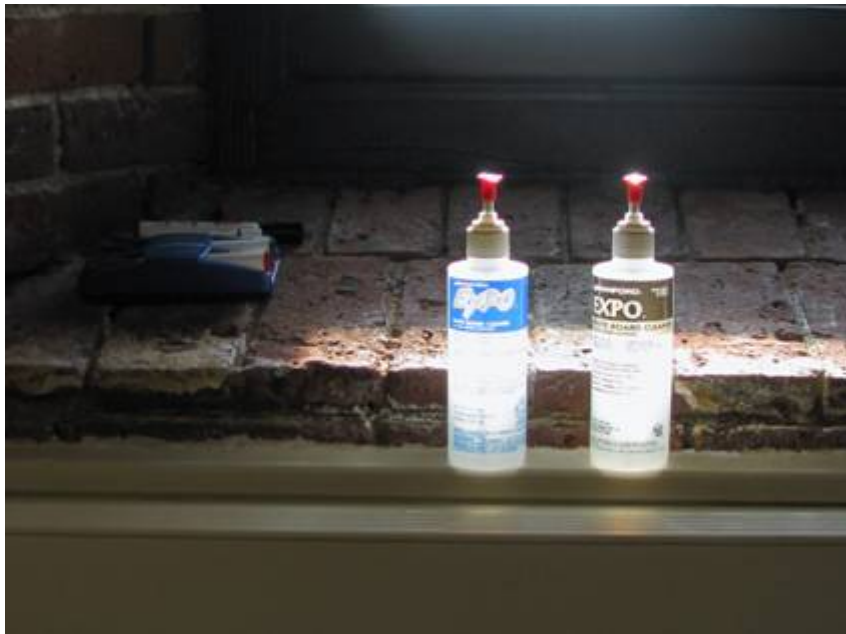
**Picture 24**

**Dry Erase Board Markers and Cleaners**

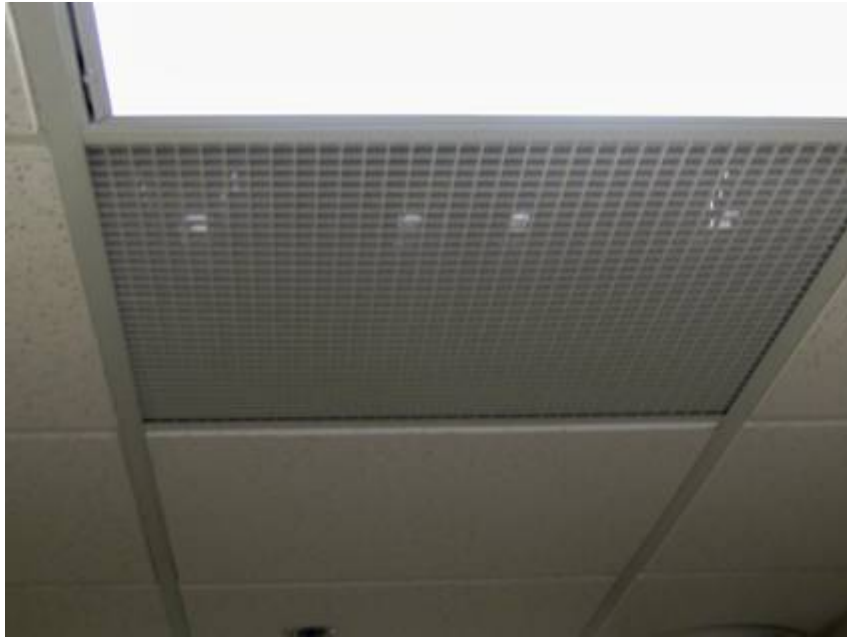
**Picture 25**

Hallway ceilings exhibited grates into ceiling plenum (Picture 25). If these grates are not necessary for the ventilation system, MRC should consider replacing them with ceiling tiles. Open ceilings can be a source, of dust, dirt and other pollutants.

**Grate Covering Ceiling Plenum**

10. Investigate ceiling grates in hallways and replace with ceiling tiles if necessary.
11. Eliminate use of pesticides on plants in the indoor environment.
